AN INVESTIGATION OF SANDSTONE CONSOLIDATION METHOD  
FOR THE NORTHERN GOPURA OF THE PHIMAI SANCTUARY,  
A KHMER MONUMENT IN THAILAND

Nuanlak Watsantachad

A THESIS  
in  
Historic Preservation

2001

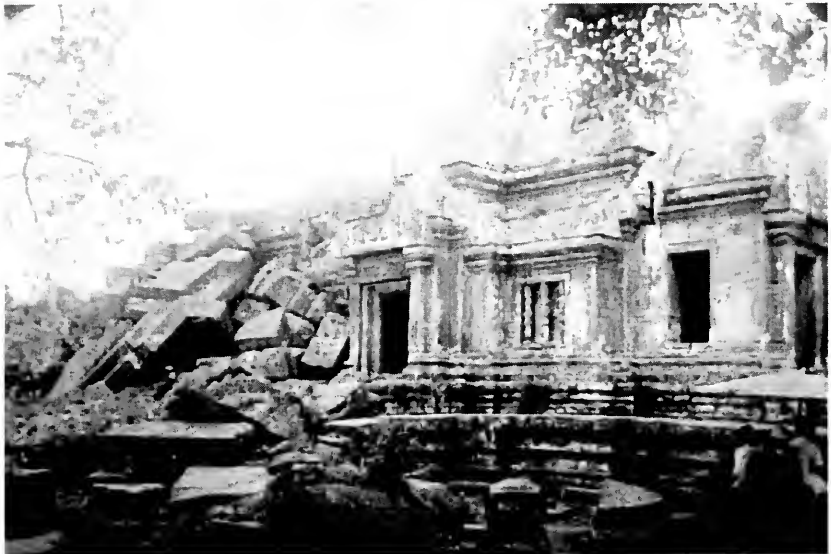
**Figure 1.2:** Collapse of the Viharn Sanctuary located in the border of Thailand and Cambodia. (July 2000)

Due to their age, many of these monuments were in a near state of collapse when the survey projects began in the early twentieth century. Only about 60% of the structures were standing while the other 40% had collapsed. Although the condition assessment of the stones—sandstone and laterite—used as building material was quite good, the construction was unstable. (See Figure 1.2)

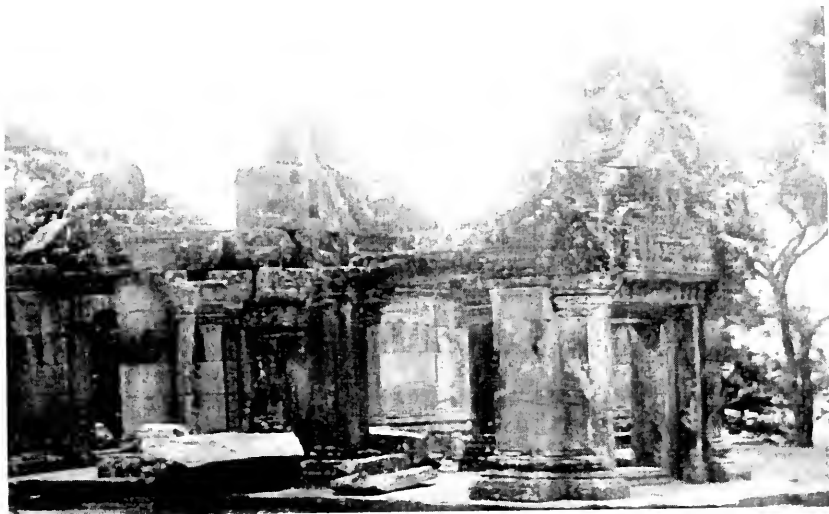
**Figure 1.4:** Interior walls and floors that are exposed due to the collapse of the roof.  
The Gallery of the Viharn Sanctuary, July 2000.

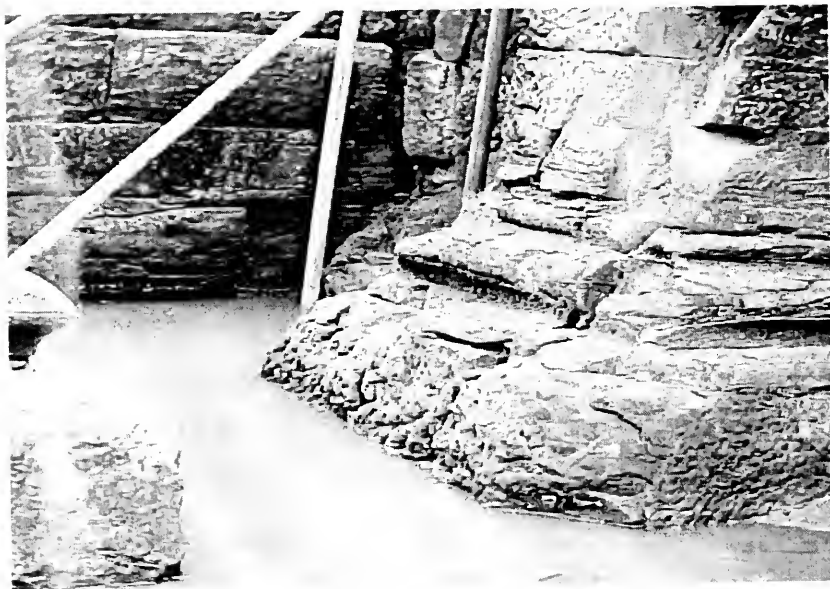
**Figure 1.5:** Unsheltered room retains water on the floor for several days before the water evaporates.  
The Northern Gopura of the Phimai Sanctuary, June 2000

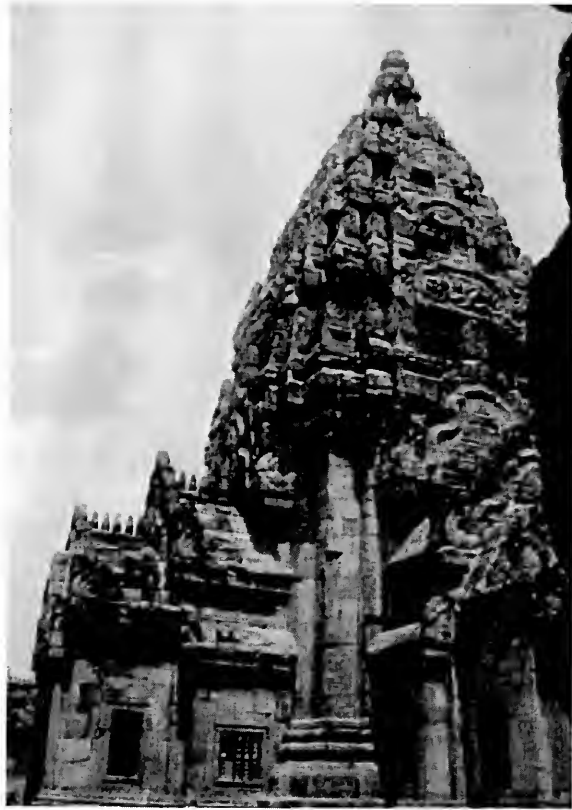
**Figure 1.8:** The Principle Tower after anastylosis restoration, 1964-1969.  
(June 2000)

The siliceous sandstone principal tower was successfully restored with anastylosis more than 30 years ago. This was carried out between 1964 and 1969 at the request of the French Ambassador in Thailand, by B.P. Groslier, who was then director of Archaeological Research at the Ecole Francais d'Extreme-Orient and Curator of the Angkor Monuments. The sanctuary was reconstructed on a new reinforced concrete foundation with an inserted bracing structure inside the walls and under the vaults, and the tower was restored to its original height. (See Figure 1.8)

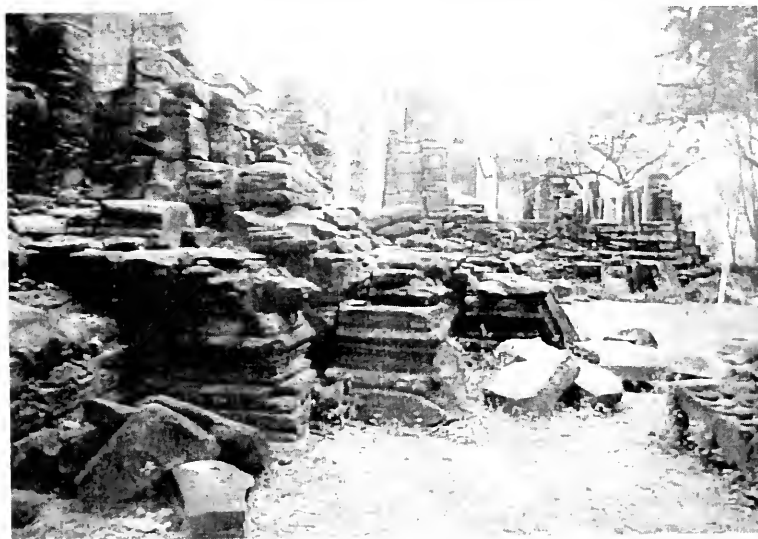
**Figure 1.10:** The condition of the Northern Gopura of the Phimai Sanctuary before restoration.  
(Fine Arts Division, the Department of Interior, 1998)

Gopuras was very critical when the survey was conducted. (See Figure 1.10) The building had collapsed, some pieces of stones had fallen down, and the stone itself was deteriorated in sections to a very high degree, as noted in 1972,

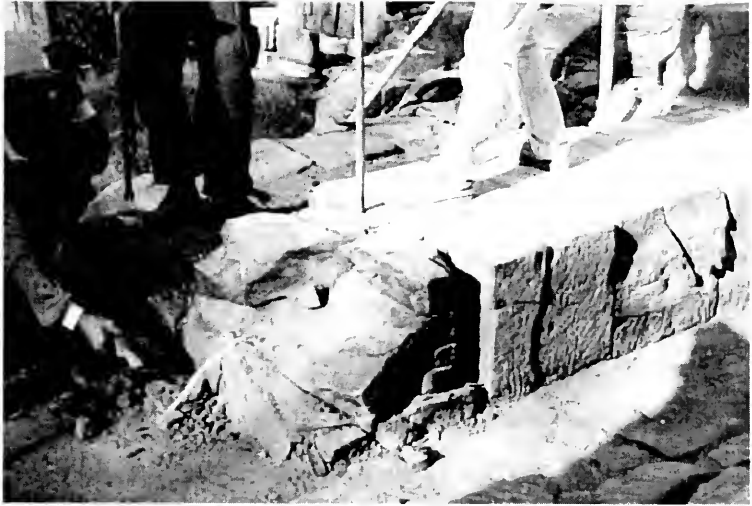
**Figure 1.11:** Ancient stone block broke during the restoration project.  
(Fine Arts Division, the Department of Interior, 1998)

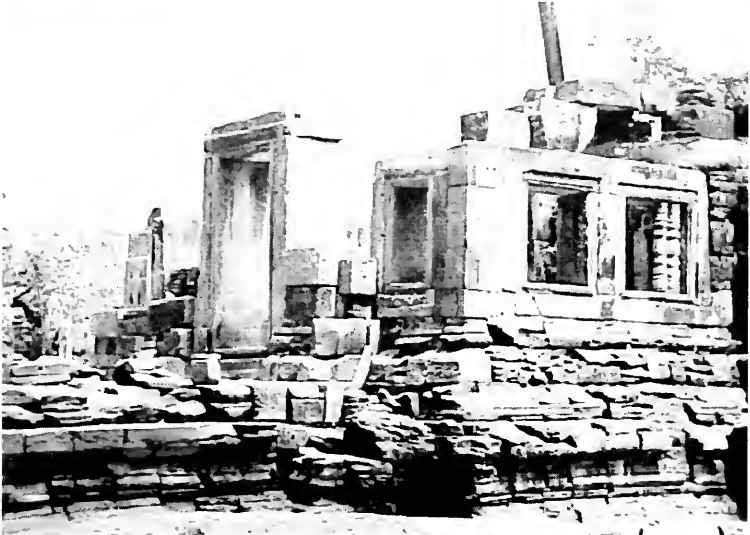
**Figure 1.12:** New stone replacement during anastolysis restoration project.  
(Fine Arts Division, the Department of Interior, 1998)

The Division of Fine Arts of the Department of the Interior in Thailand recently attempted to restore the Northern Gopura by anastylosis. They tried to follow the previous successful reconstruction project carried out on the main sanctuary in 1962. All of the remaining stones were dismantled first and new concrete was poured before replacing the historic stones into their original locations. Unfortunately, because of the extremely disaggregated and delaminated condition of the stone blocks, most of them were damaged during dismantling and were not reusable. (See Figure 1.11) Subsequently, new stone replacements were obtained in order to re-construct the Gopura; the new stone was brought from quarries in Sikhew district in the Nakhon Ratchasima Province, and, although the same type of sandstone, the fresh stone contains more mica than the ancient stone. Hence, the original concept and purpose of the preservation project—to preserve the ancient stones and original construction—had to be changed due to the loss of the original masonry. Consequently, the project might be considered a failure from the point of view of conservation although it was a successful reconstruction. (See Figure 1.12)

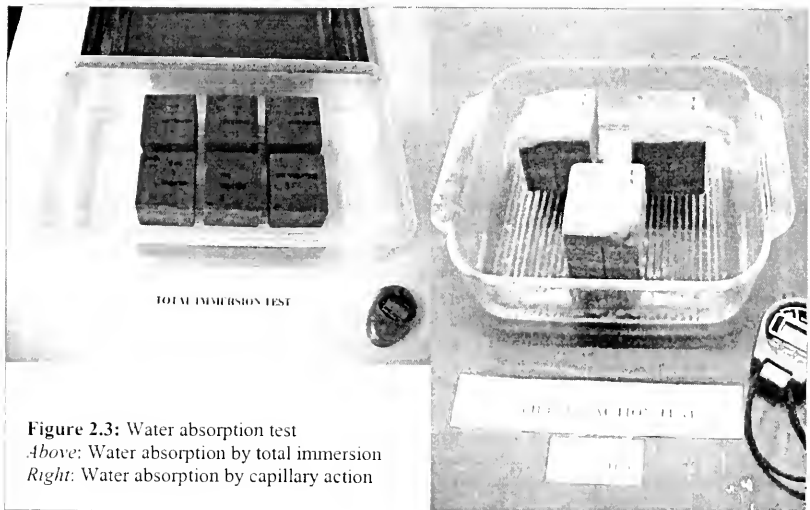
**Figure 2.3:** Water absorption test  
*Above:* Water absorption by total immersion  
*Right:* Water absorption by capillary action

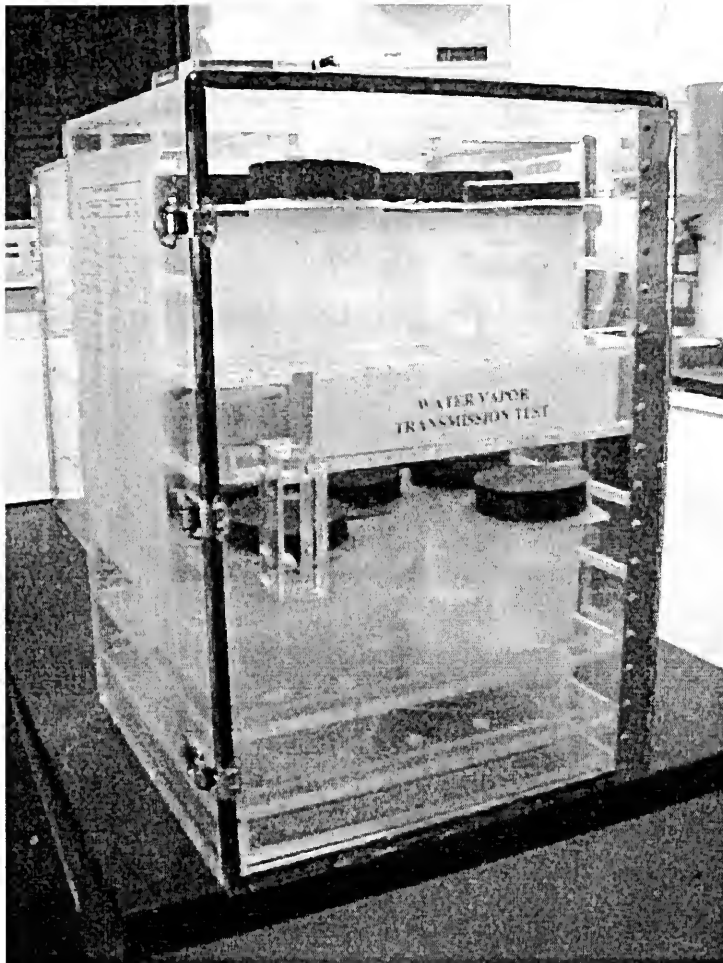
**Figure 2.4:** Water vapor transmission test

The assemblies were placed in a desiccator under the average temperature of 69°F and the average relative humidity of 18.5%

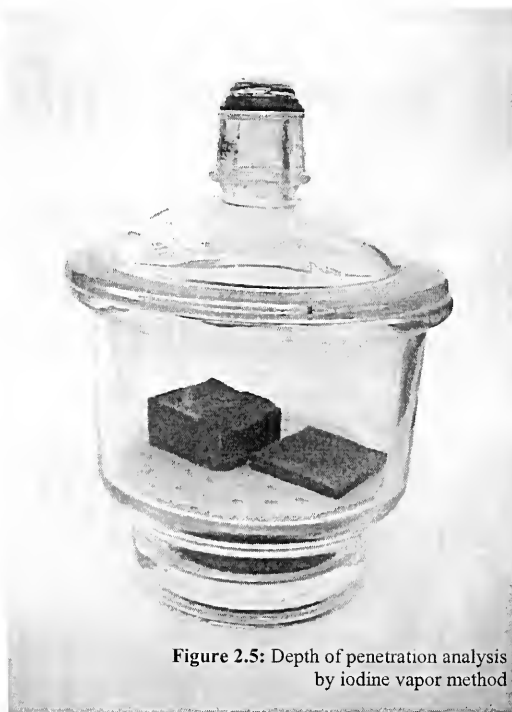
**Figure 2.5:** Depth of penetration analysis by iodine vapor method

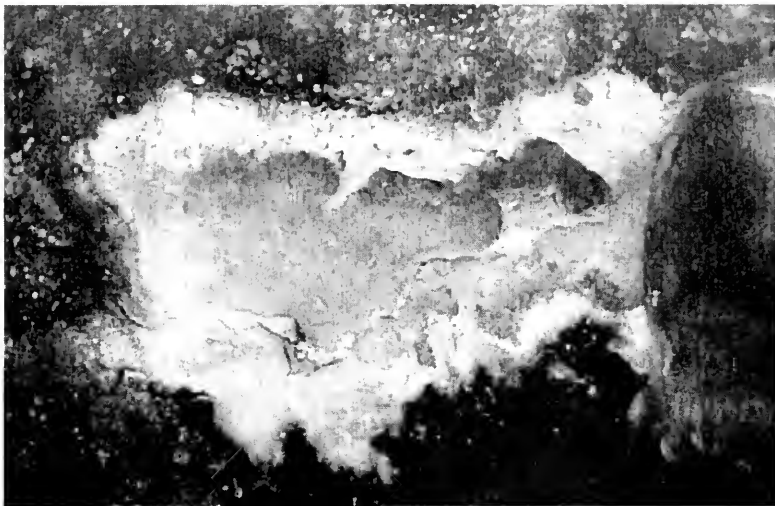
**Figure 4.1:** Flaking of sandstone surface  
The evidence of dampness in stone leading to the flaking of thin layers of the stone surface.  
Stone condition under the lintel of the Northern Gopura's Hall(June 2000)

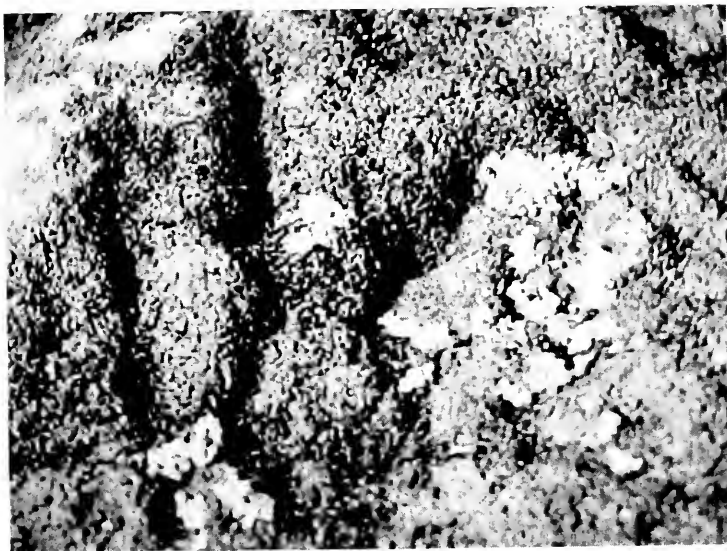
**Figure 4.4:** Lichen on sandstone surface. The biological growth indicates an evidence of dampness in the sandstone of the Northern Gopura's wall. (June 2000)

There are some evidences of biological growth depositing on the sandstone of the Northern Gopura of the Phimai Sanctuary. The types of biological growth and their effect, however, need further study in order to provide appropriate treatments to the stone, such as cleaning and protection, which will not be investigated and discussed in this thesis. (See Figure 4.4)
